Monitoring Data Record

Project Title: I-2511CB (I-85 Widening) COE Action ID: 200221534
Stream Name: Town Creek (Site 5) DWQ Number: 040271
City, County and other Location Information: Rowan County, I-85 Widening (-TI-PINC Sta. 20+35)
Date Construction Completed: Water turned on 12/6/06, Stream reforestation completed 12/13/06
Monitoring Year: (1) of 5
Ecoregion: _____ 8 digit HUC unit 03040103
USGS Quad Name and Coordinates: _____

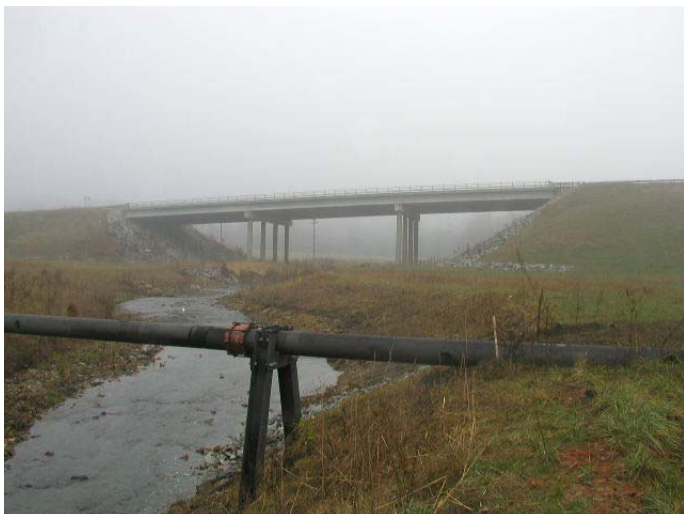
The buffer area was missing alot of bareroot seedlings.

(Overview looking downstream of buffer area)

Estimated causes, and proposed/required remedial action: The buffer area will be replanted by March 2008.

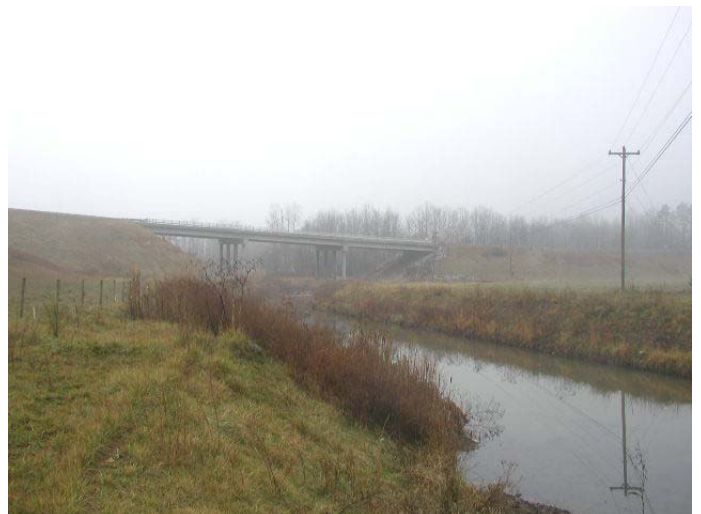
(Overview looking upstream of buffer area)
